UI Bulletin #123d

Subject:	Roof Beacon (TRW) Switch Wiring Location/Access
Models Years Affected:	2014-19 Chevrolet Silverado 1500 LD 2014-19 GMC Sierra 1500 LD 2015-19 Chevrolet Silverado 2500/3500 HD 2015-19 GMC Sierra 2500/3500 HD 2019 – beyond Chevrolet Silverado MD Trucks With option TRW
Origination Date:	February 6, 2015
Revision Date:	May 11, 2020

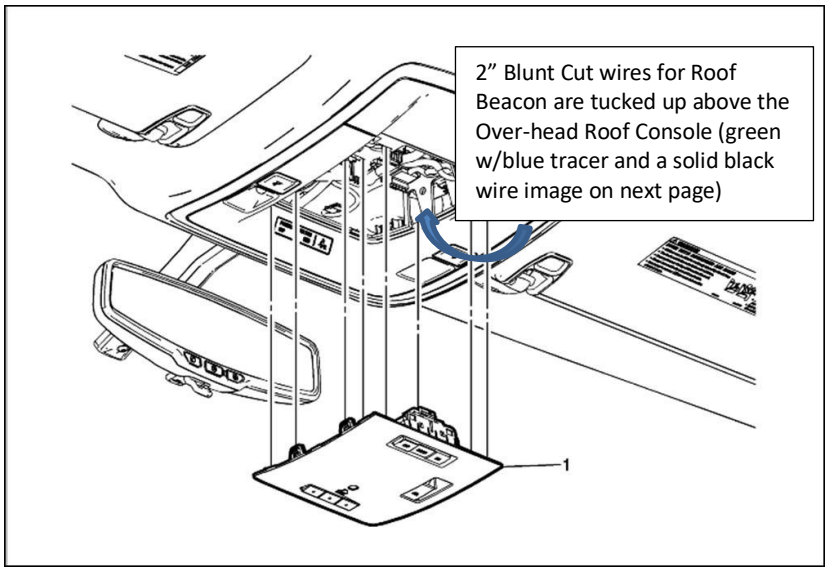
2" Blunt Cut wires for Roof Beacon are tucked up above the Over-head Roof Console (green w/blue tracer and a solid black wire image on next page)
1

To access the blunt cut wires for the roof beacon, remove center section of the Roof Console as follows…

1. Use a flat bladed plastic trim tool in order to release the retainer clips securing the trim plate to the roof console assembly.

2. Disconnect electrical connections where/when required.
